# PRODUCT SUPPORT.....SERVICE NEWS

<b>BULLETIN NO.:</b> 2004-018A	<b>DATE:</b> March 15, 2007 (Rev.)	<b>PAGE:</b> 1 of 1
<b>TITLE:</b> Removal of Trunnion Grease Vents		<b>RELEASE:</b> Dealer/Customer
<b>SECTION:</b> Axle		<b>MODEL:</b> All ZIV/ZIV-2/ZV/ZV-2

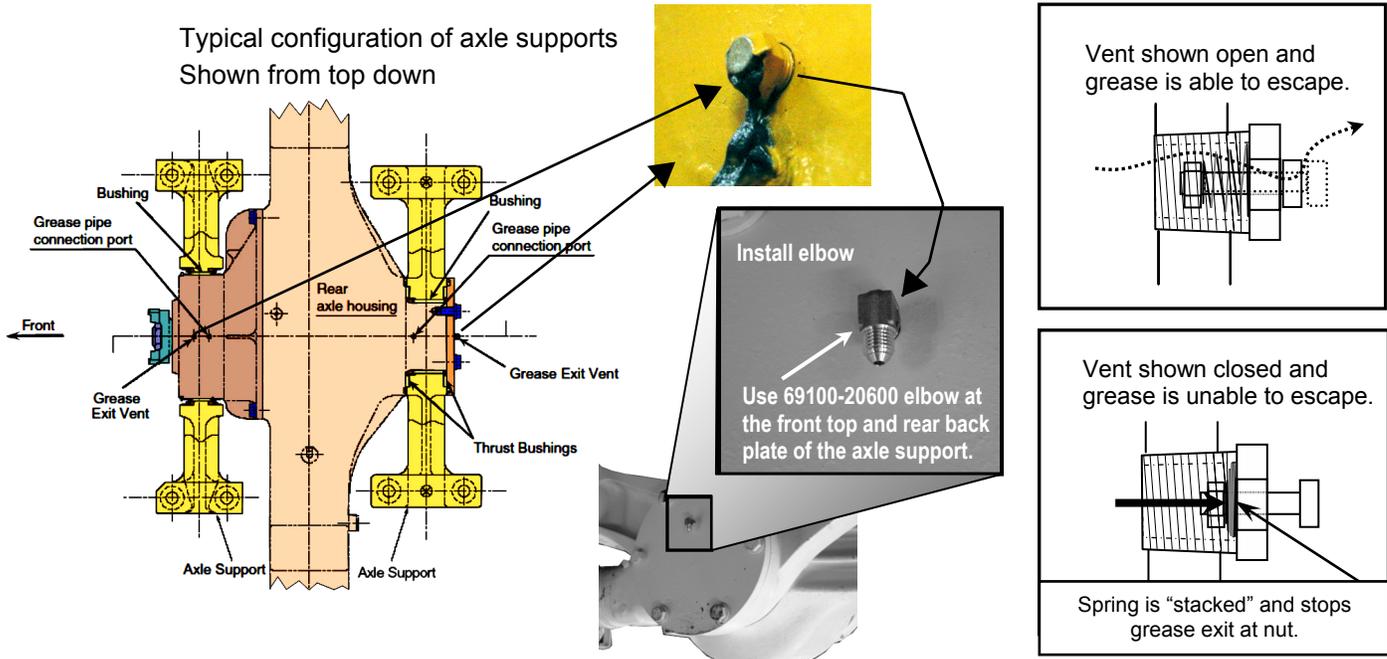
However, when using industrial high volume, high pressure type grease guns that are operated electrically, hydraulically or pneumatically, the grease vent can receive such a massive amount of grease in such a short span of time that it simply seals up, and does not permit grease passage. Use of NLGI 2 type grease can have the exact same effect.

This can result in lip and o-ring seals being forced open, and if open long enough in such a position that gravity can feed dirt or sand into the immediate area of the seal, this can eventually contribute to bushing failure as dirt or sand gets worked into the bushing area.

Remove 41100-60020 breather

Kawasaki's recommendation is that if machine is going to be lubricated with a high volume, high pressure type grease system, or if NLGI 2 grease is used, these grease vents should be removed from trunnion axle support assemblies & two of a 69100-20600 elbow put in their place to direct grease to go away from grease exit point. At rear plate, direct grease downward. Dispose of this grease according to appropriate regulations.
