PRODUCT SUPPORT.....SERVICE NEWS

BULLETIN NO.: 2004-018A	DATE: March 15, 2007 (Rev.)	PAGE: 1 of 1
TITLE: Removal of Trunnion Grease Vents		RELEASE: Dealer/Customer
SECTION: Axle		MODEL: All ZIV/ZIV-2/ZV/ZV-2

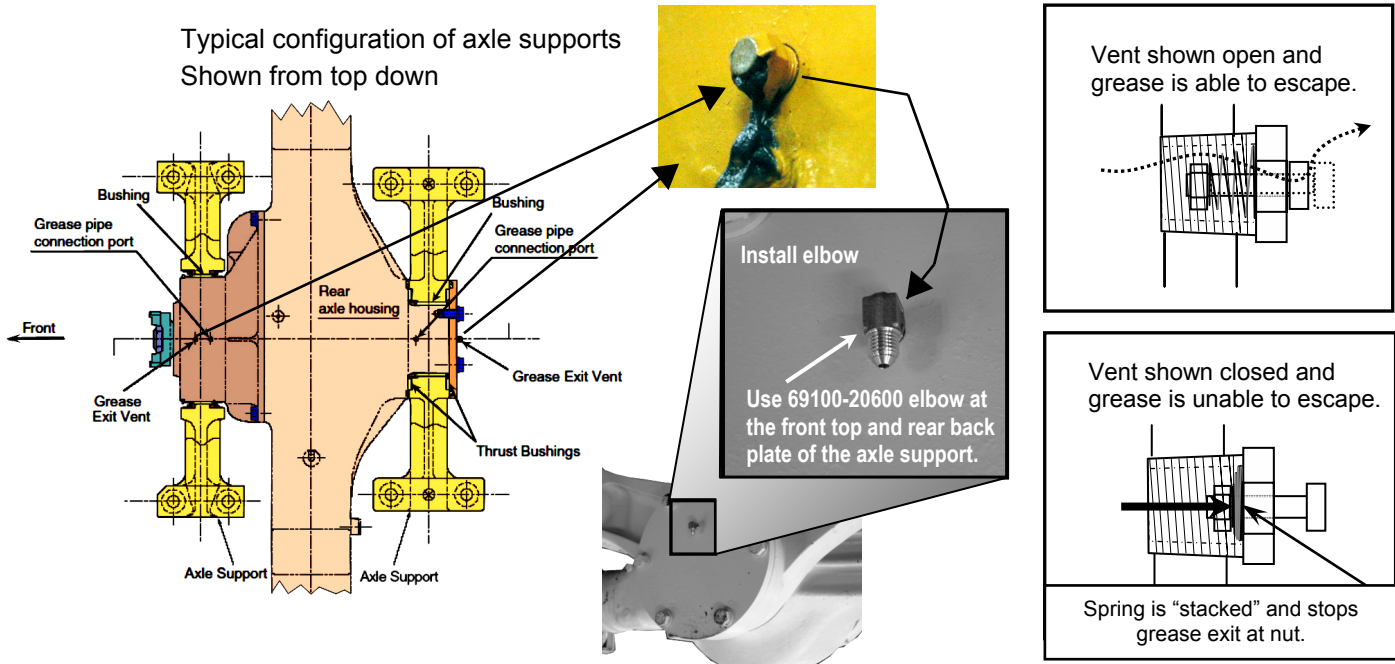
However, when using industrial high volume, high pressure type grease guns that are operated electrically, hydraulically or pneumatically, the grease vent can receive such a massive amount of grease in such a short span of time that it simply seals up, and does not permit grease passage. Use of NLGI 2 type grease can have the exact same effect.

This can result in lip and o-ring seals being forced open, and if open long enough in such a position that gravity can feed dirt or sand into the immediate area of the seal, this can eventually contribute to bushing failure as dirt or sand gets worked into the bushing area.

Remove 41100-60020 breather

Kawasaki's recommendation is that if machine is going to be lubricated with a high volume, high pressure type grease system, or if NLGI 2 grease is used, these grease vents should be removed from trunnion axle support assemblies & two of a 69100-20600 elbow put in their place to direct grease to go away from grease exit point. At rear plate, direct grease downward. Dispose of this grease according to appropriate regulations.
